### **DETERMINING EFFECTIVENESS OF WILDLIFE-VEHICLE COLLISION MITIGATION PROJECTS: PHASE I**

#### **Final Report**

Prepared by:  
Arizona Game and Fish Department  
Phoenix, Arizona

# Report R917034

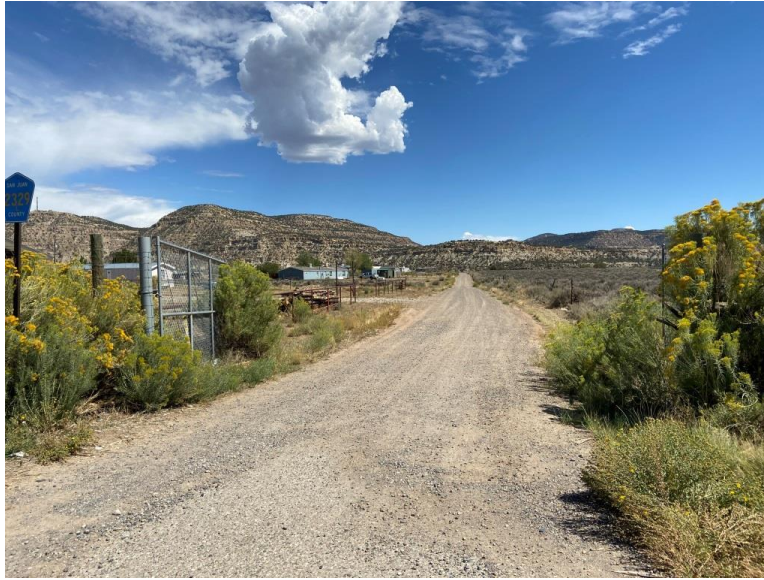
In 2016, 12 years after the Aztec Project had been completed, the research team noted that a number of gates were opened and precluded from closing by established vegetation (Figure 44). Some appeared to be recently locked and unofficially signed (Figure 45). One gate was open and closed by local residents, who also monitored the gate's entrance with a closed-circuit video camera (Figure 46). NMDOT, NMDGF, and the research team suspected that deer were using the open gates to enter the US 550 ROW.

**FIGURE 44** Vegetation precluded an Aztec game fence gate from closing north of Aztec on US 550 within San *Juan County, New Mexico*

**Recommendation** – Install game guards instead of gates to address lateral access roads with more than a few vehicles per month in areas with existing game fencing.

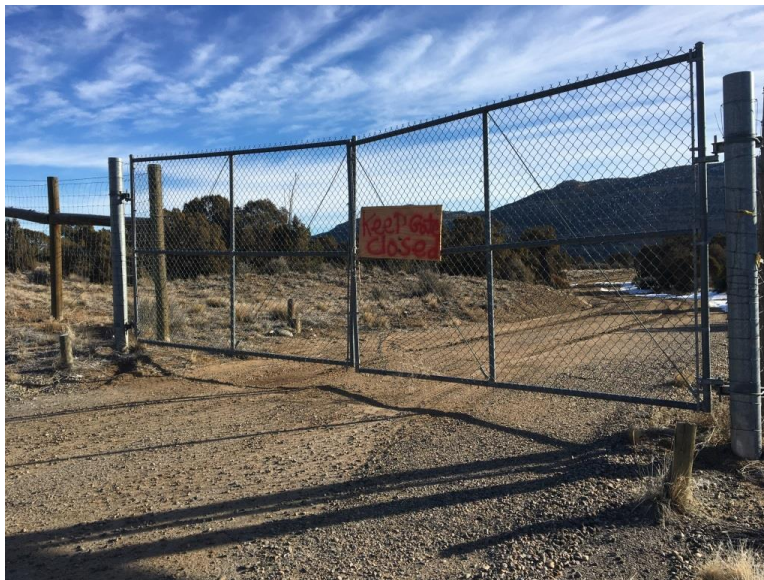
**FIGURE 45** Game fence gate locked and unofficially signed north of Aztec on US 550 within San Juan County, New Mexico

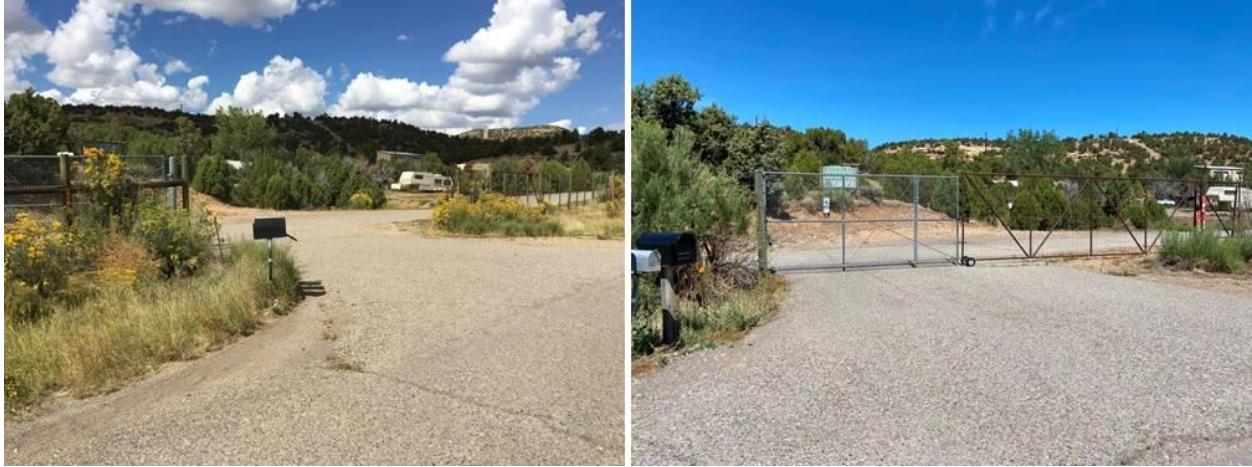
**FIGURE 46 Game fence gate opened and closed by local residence north of Aztec on US 550 within San Juan County, New Mexico**

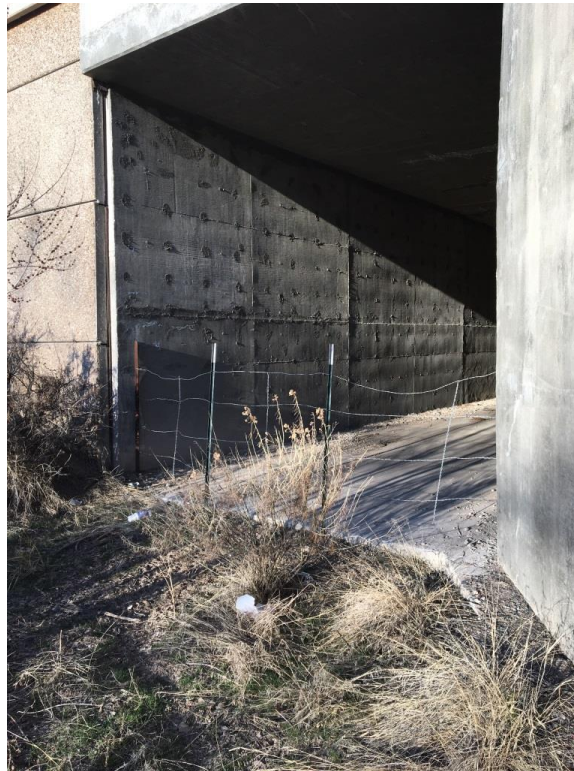
At the beginning of Phase One, the research team noted that two project areas, Raton and Aztec, each had a CBC wildlife crossing structure obstructed. Raton's Unnamed CBC, located at milepost 454.2 on I-25, had a steel corral panel spanning its eastern opening (Figure 49). The panel appeared to be recently placed and intended to prevent horses from leaving the horse owner's property located adjacent to the structure. Aztec's obstructed CBC, located at milepost 172.2 on US 550, had a four-strand barbed wire fence attached to its eastern opening (Figure 50). The fence's aged barbed wire, rusted angle iron CBC attachment points, and information from NMDGF indicated that the fence had been in place for a number of years, possibly since the completion of the project in 2004.

**FIGURE 50** A barbed wire fence obstructing a Concrete Box Culvert opening north of Aztec on US 550 within San Juan County, New Mexico

**Recommendation** – If fences or gates are needed for livestock management, use a wildlife friendly fence design (42-in. tall 4-strand wire fence) and place on the ROW boundary.

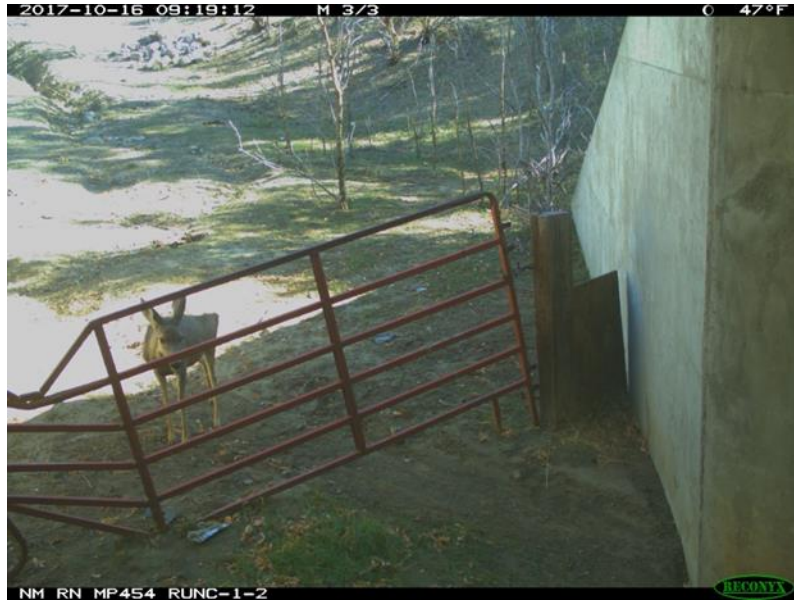
At the beginning of Phase One, the Raton and Aztec project areas each had a CBC wildlife crossing structure obstruction, which was removed by NMDOT and eventually replaced with a wildlife friendly ROW fence. Raton's CBC obstruction, after initial removal by NMDOT, was reinstalled by unknown parties and remained in place from July 16, 2017 to October 18, 2017. The research team considered this second installation to be a "short-term" obstruction placed on a functioning wildlife crossing structure. Aztec's CBC obstruction, which was in place at the beginning of Phase One, was reported by NMDGF to have likely been in place since the CBC was constructed. The research team considered this obstruction to be a "long-term" obstruction placed on a newly constructed wildlife crossing structure that had yet to be habituated to by wildlife.

**FIGURE 69 An obstruction (steel corral panel) preventing a Raton deer from using the Unnamed Concrete Box Culvert on I-25 within Colfax County, New Mexico**

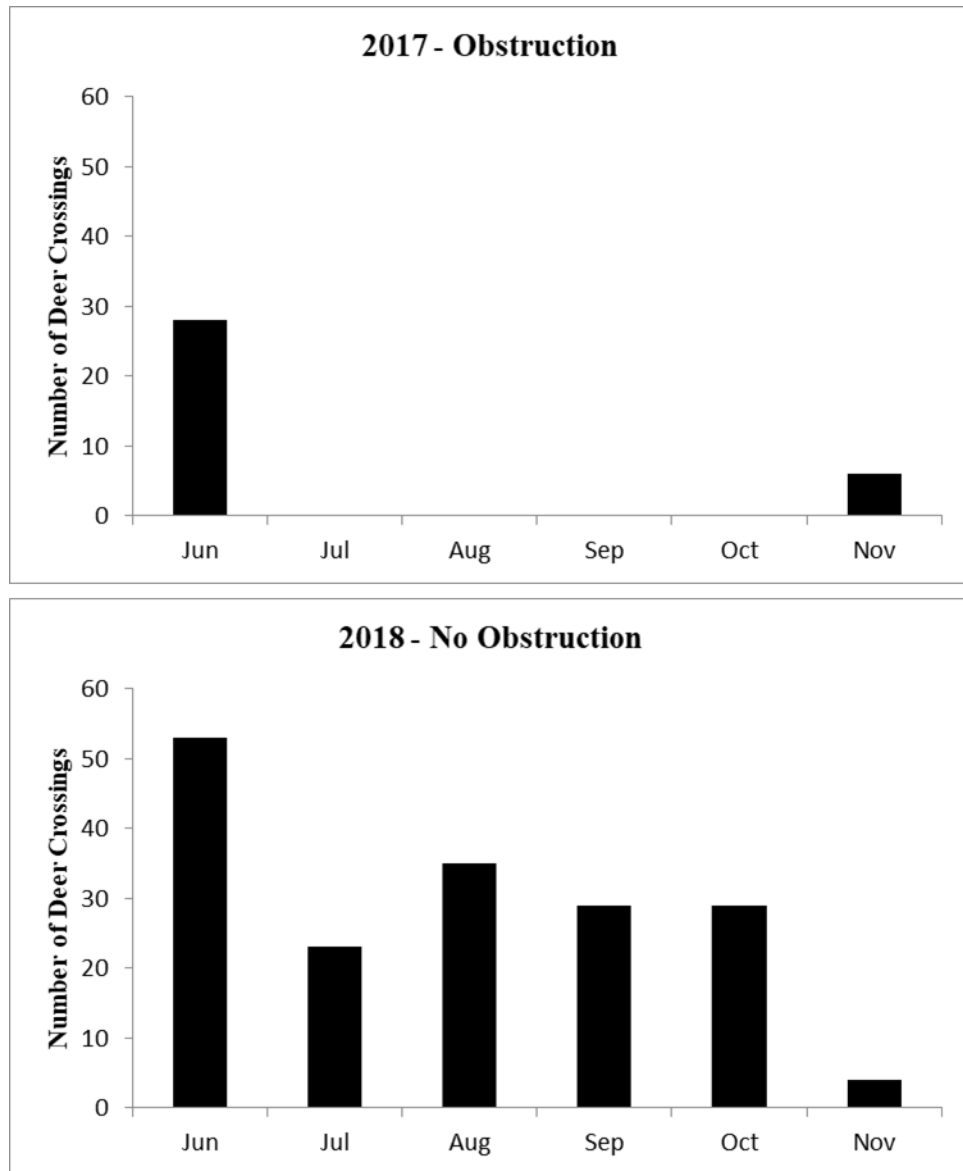
**FIGURE 70 Documented deer use at the Raton Unnamed Concrete Box Culvert with obstruction (top) and without obstruction (bottom) on I-25 within Colfax County, NM**

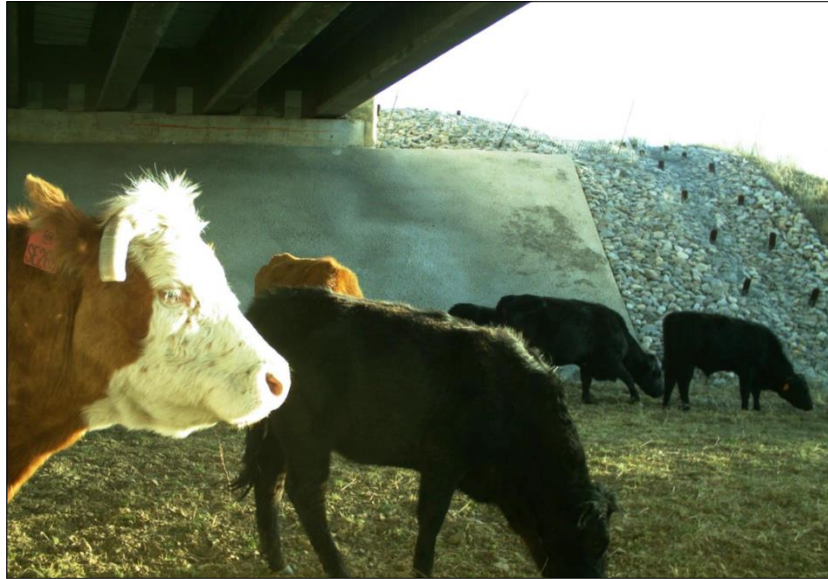
**FIGURE 72** Cattle using the North Rio Puerco Bridge located on US 550 at milepost 53.6 south of Cuba within Sandoval County, New Mexico

**Recommendation** – Limit livestock access to the wildlife crossing structure by installing a wildlife friendly ROW fence.

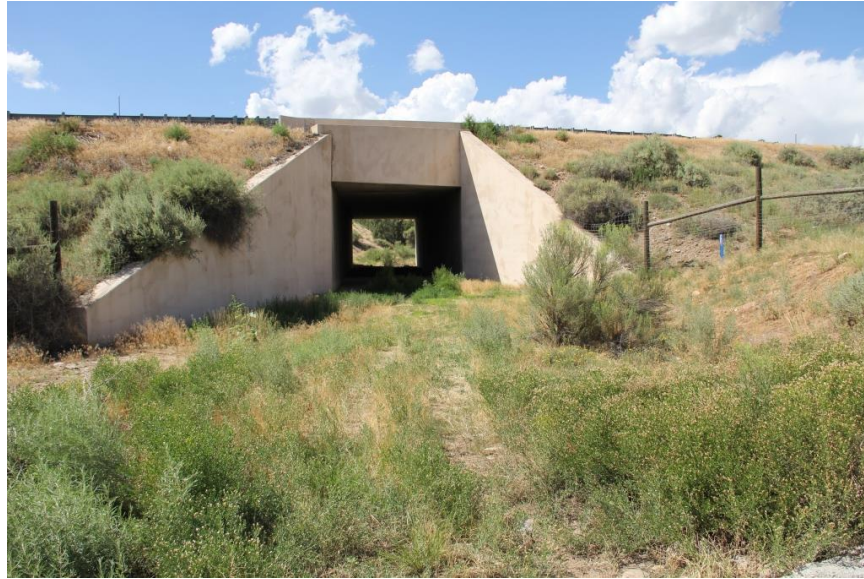
**FIGURE 77 The upsized Concrete Box Culvert (16-ft tall x 20-ft wide x 120-ft long) located on US 550 north of Aztec within San Juan County, New Mexico is adequate for mule deer passage**

**Recommendation** – Consider replacing smaller culverts with CBCs that are 16-ft tall x 20-ft wide x 120-ft long in areas with high DVC occurrence. Consult with NMDOT Environmental Bureau and NMDGF if upsized culverts need to be longer than 120-ft to accommodate wider roadways.

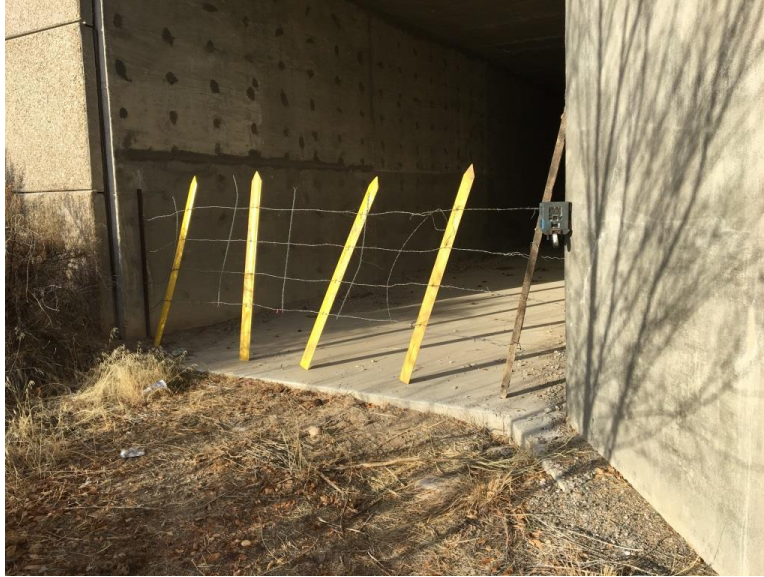
Deer and other wildlife will often adapt and use relatively small, short-length CBCs to cross under a roadway. However, when these structures are obstructed by a fence or other obstacle (Figure 80), most deer will cease use due to the obstruction. This was observed in both the Raton and Aztec projects when deer crossings went from 1,264 crossings without an obstruction to 4 crossings with

**FIGURE 80 A barbed wire fence obstructing a CBC opening north of Aztec on US 550 within San Juan County, New Mexico**

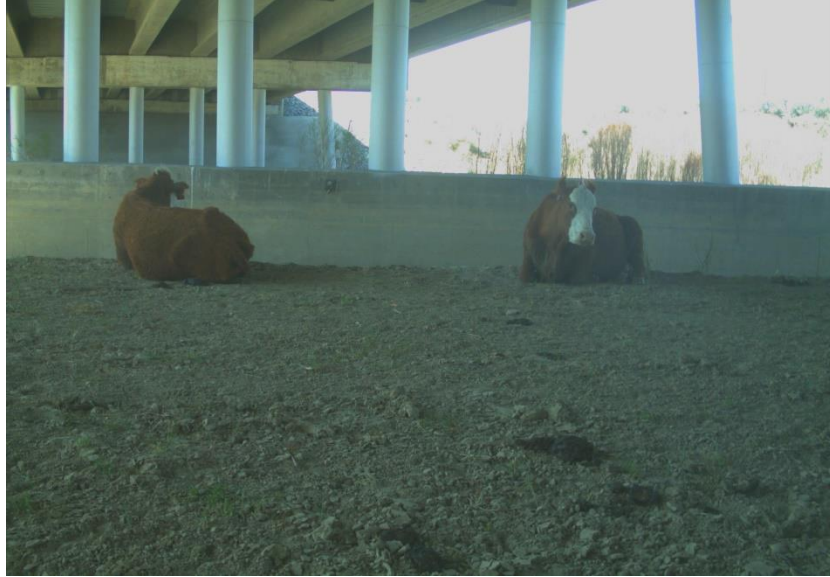
**FIGURE 83 Cattle using the shade under the North Rio Puerco Bridge located on US 550 south of Cuba within Sandoval County, New Mexico**
