### **DETERMINING EFFECTIVENESS OF WILDLIFE-VEHICLE COLLISION MITIGATION PROJECTS: PHASE I**

#### **Final Report**

Prepared by:  
Arizona Game and Fish Department  
Phoenix, Arizona

# Report R917034

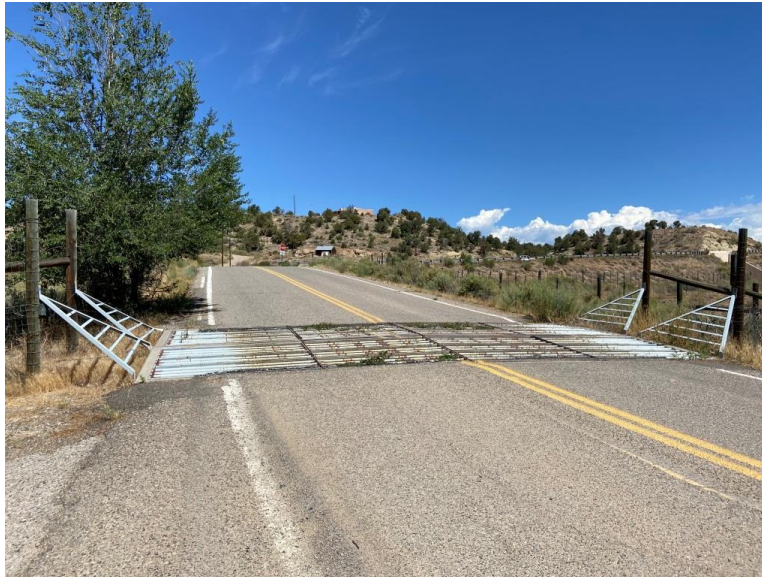
The research team installed still cameras at two gates that were opened and precluded from closing by established vegetation, as well as the one gate opened and closed by local residents. In addition, one game guard (Figure 47) was monitored within the project area to determine if wildlife were entering the US 550 ROW at these locations.

**FIGURE 47 Monitored game guard north of Aztec on US 550 within San Juan County, New Mexico**

**Recommendation** – Install game guards instead of gates to address lateral access roads with more than a few vehicles per month in areas with existing game fencing.

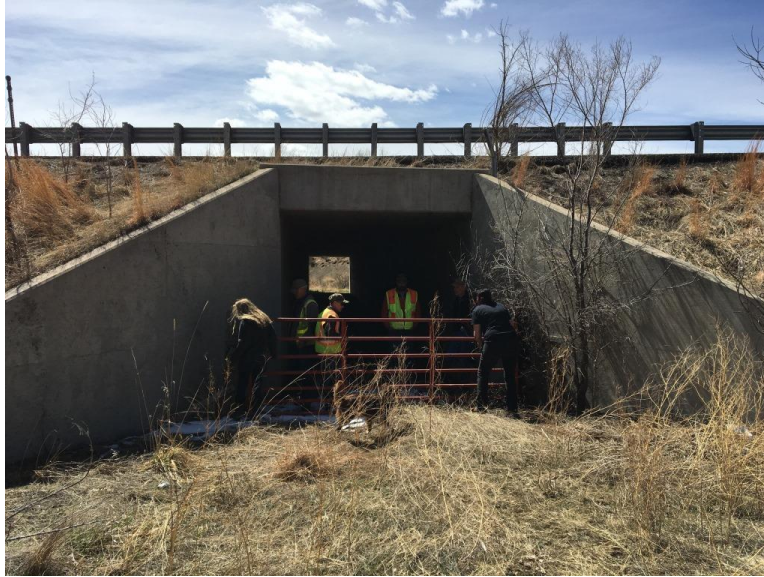
At the beginning of Phase One, the research team noted that two project areas, Raton and Aztec, each had a CBC wildlife crossing structure obstructed. Raton's Unnamed CBC, located at milepost 454.2 on I-25, had a steel corral panel spanning its eastern opening (Figure 49). The panel appeared to be recently placed and intended to prevent horses from leaving the horse owner's property located adjacent to the structure. Aztec's obstructed CBC, located at milepost 172.2 on US 550, had a four-strand barbed wire fence attached to its eastern opening (Figure 50). The fence's aged barbed wire, rusted angle iron CBC attachment points, and information from NMDGF indicated that the fence had been in place for a number of years, possibly since the completion of the project in 2004.

The Raton and Aztec CBC obstructions were removed by NMDOT at the beginning of Phase One. However, the obstructions were reinstalled by unknown parties during the project, and once again removed by NMDOT. After the obstructions were removed for the second time, to prevent reinstallation, NMDOT erected wildlife friendly fences away from the CBCs' openings along the ROW boundary. The obstructions were not reinstalled for the remainder of Phase One.

**FIGURE 49** A steel corral panel obstructing a Concrete Box Culvert opening in Raton on I-25 within Colfax County, New Mexico

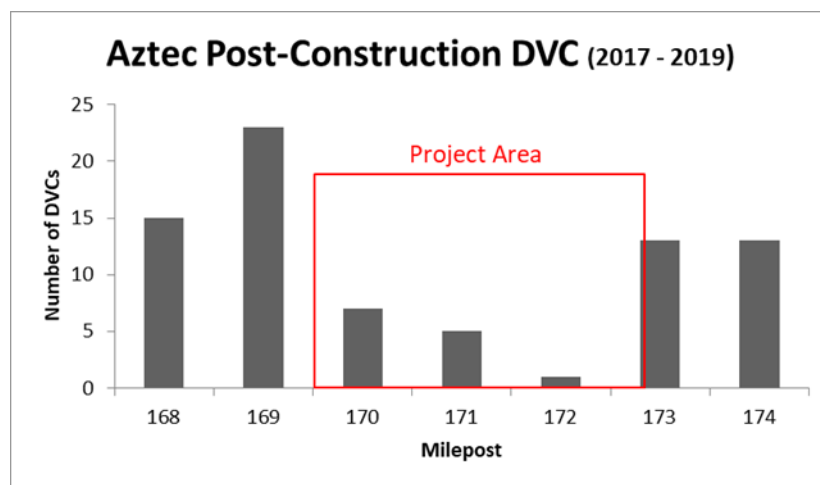
Patrol Yard data from 2017 to 2019 (data was not collected in 2016) shows that the three mile Aztec project area had relatively few DVCs (13) when compared to the adjacent two miles of roadway on either end of the project (64) (Figure 64). The adjacent two miles of roadway on either end of the project had 64 DVC, which averages to 16 DVC per mile compared to 13 DVC per mile within the project area, an average of approximately 5 DVC per mile. Thus, when using the documented DVCs on the adjacent two miles of roadway as a predictor for the number of DVCs that would be expected to occur within the project area, the project area had an 80 percent reduction in expected DVCs.

**FIGURE 64 The US 550 project area north of Aztec has fewer deer-vehicle collisions than roadway outside the project. Data from Patrol Yard carcass collection**

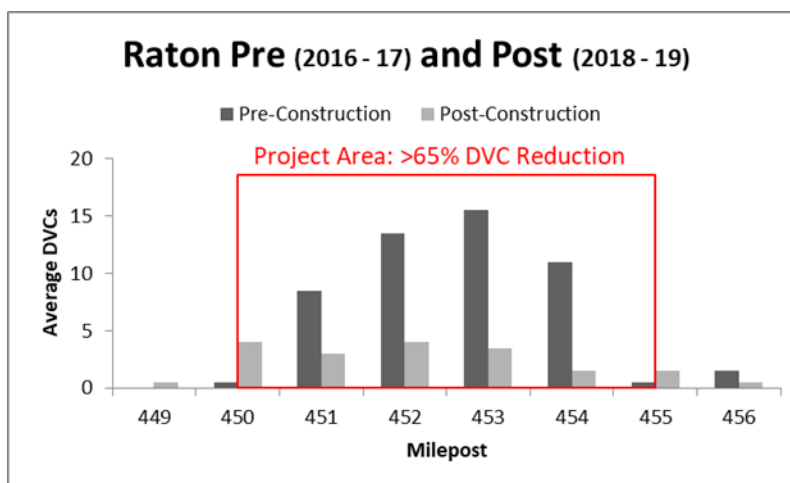
The Raton Patrol Yard carcass collection data (2016 to 2019) indicated that, prior to completion, the project area had 102 DVCs. After project completion, 35 DVCs were recorded, which equates to approximately a 66 percent reduction in DVCs (Figure 65). These preliminary findings, based on carcass collection data, suggest that the Raton mitigation project is effectively reducing WVCs.

**FIGURE 65 The Raton Project within Colfax County, New Mexico reduced deer-vehicle collisions by more than 65 percent. Data from Patrol Yard carcass collection**

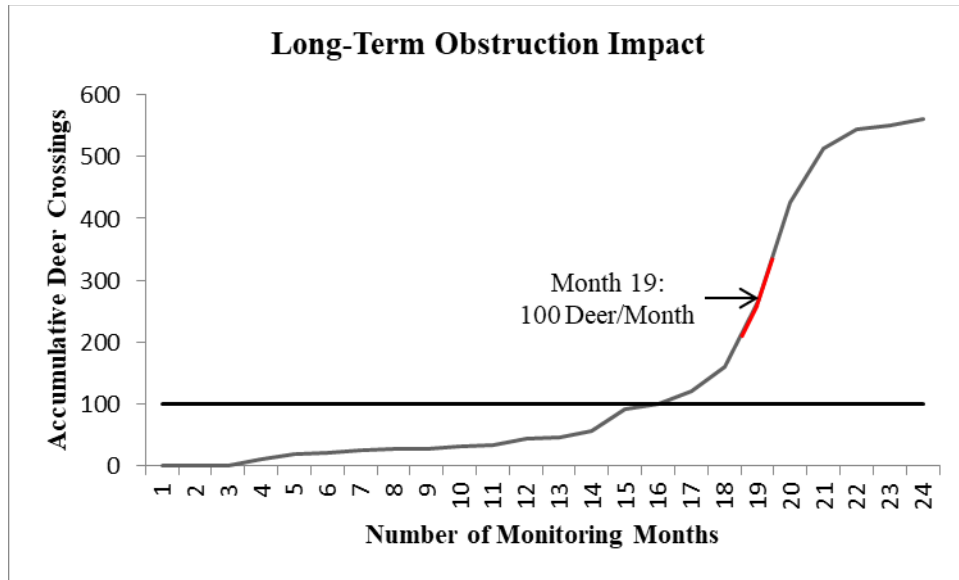
two other CBC crossing structures. The previously obstructed CBC required 16 months to accumulate 100 total deer crossings (Figure 69), which is an average of 6.25 deer crossings per month. The other two CBCs each accumulated 100 deer crossings during the first month of monitoring. The previously obstructed CBC required 19 months without an obstruction to have 100 deer crossings in a single month (Figure 71).

**FIGURE 71 Accumulated deer use after an obstruction was removed from an Aztec Concrete Box Culvert north of Aztec on US 550 within San Juan County, New Mexico**

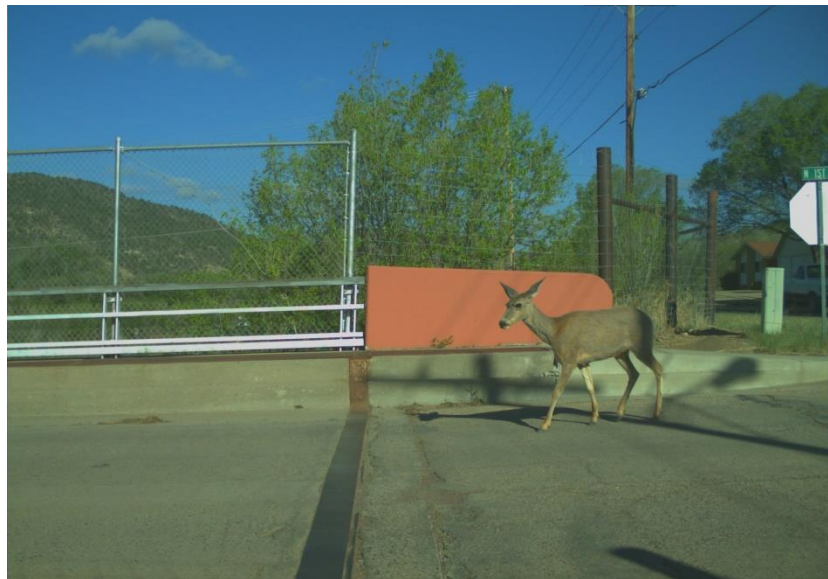
At Tijeras, the research team identified and documented two male deer, traveling together, using the at-grade Wildlife Crosswalk on NM 333 and then crossing under I-40 via the East Bridge. The path used by these deer demonstrates a habitat connection between the Sandia and Manzano mountain ranges, which are located on either side of these roadways. This finding, along with the reduction in WVCs, validates the conclusion that adding game fencing to function with existing roadway structures can reduce WVC and habitat fragmentation. In Raton, where the deer herd appears to be predominately residential and habituated to the town, the research team has documented that: 1) deer are using two six foot wide dirt “sidewalks” on either side of a trafficked residential road underpass to successfully cross under I-25 (Figure 75); and 2) deer are crossing over I-25 via a trafficked residential bridge overpass (Figure 76).

**FIGURE 76** Deer using the Raton I-25 First Street Bridge structure within Colfax County, New Mexico

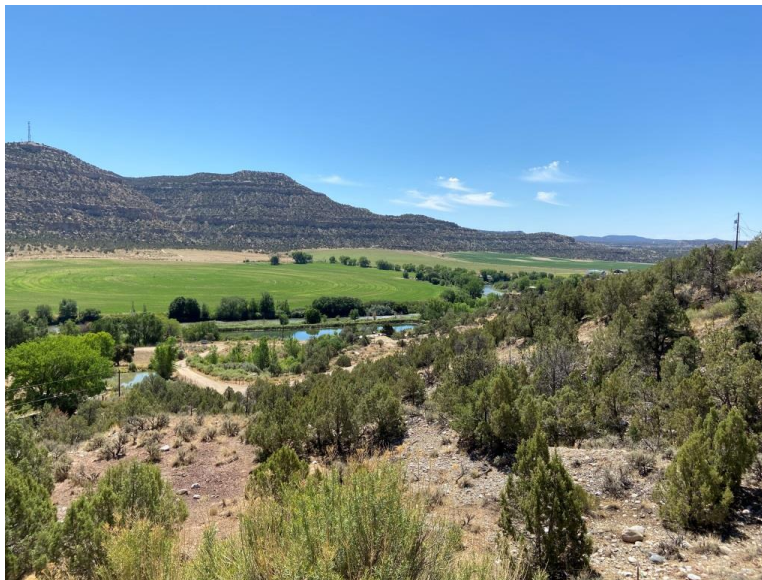
**FIGURE 78 The upsized Concrete Box Culvert passage structures located on US 550 north of Aztec within San Juan County, New Mexico are placed near frequently accessed deer resources (agricultural field and water)**

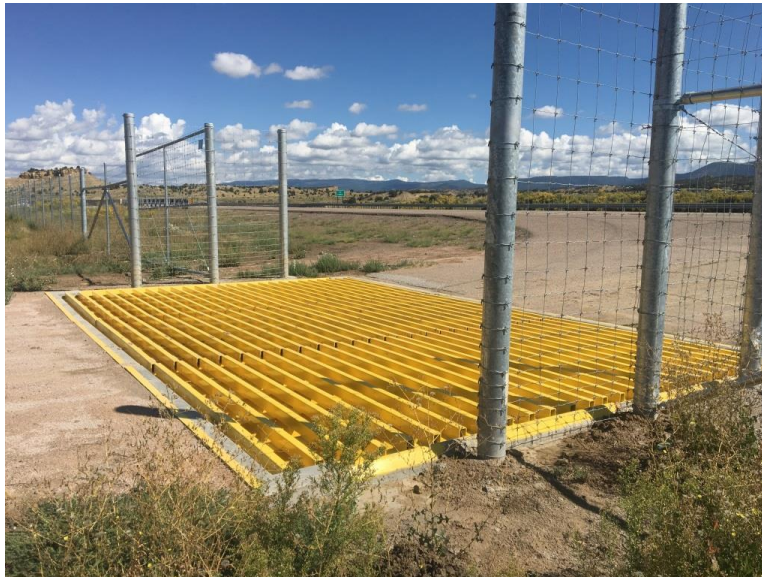
In New Mexico, Aztec exemplifies this scenario; although thousands of deer used the crossings, the continued DVCs due to open gates limits the project's success. To address this issue, NMDOT obtained funds from the Highway Safety Improvement Program (HSIP), which will be used to replace open gates with game guards (Figure 79). Although deer can occasionally cross them, well-designed guards are ultimately effective at limiting ungulate access to the ROW (23).

**Conclusion** – Gates are regularly left open and increase the risk of WVC. Gates should be avoided, kept locked, and/or only used on lateral access roads with very low traffic volume (a few cars per month).

**FIGURE 79 Game guard installed across a US 550 lateral access road south of Cuba within Sandoval County, New Mexico**

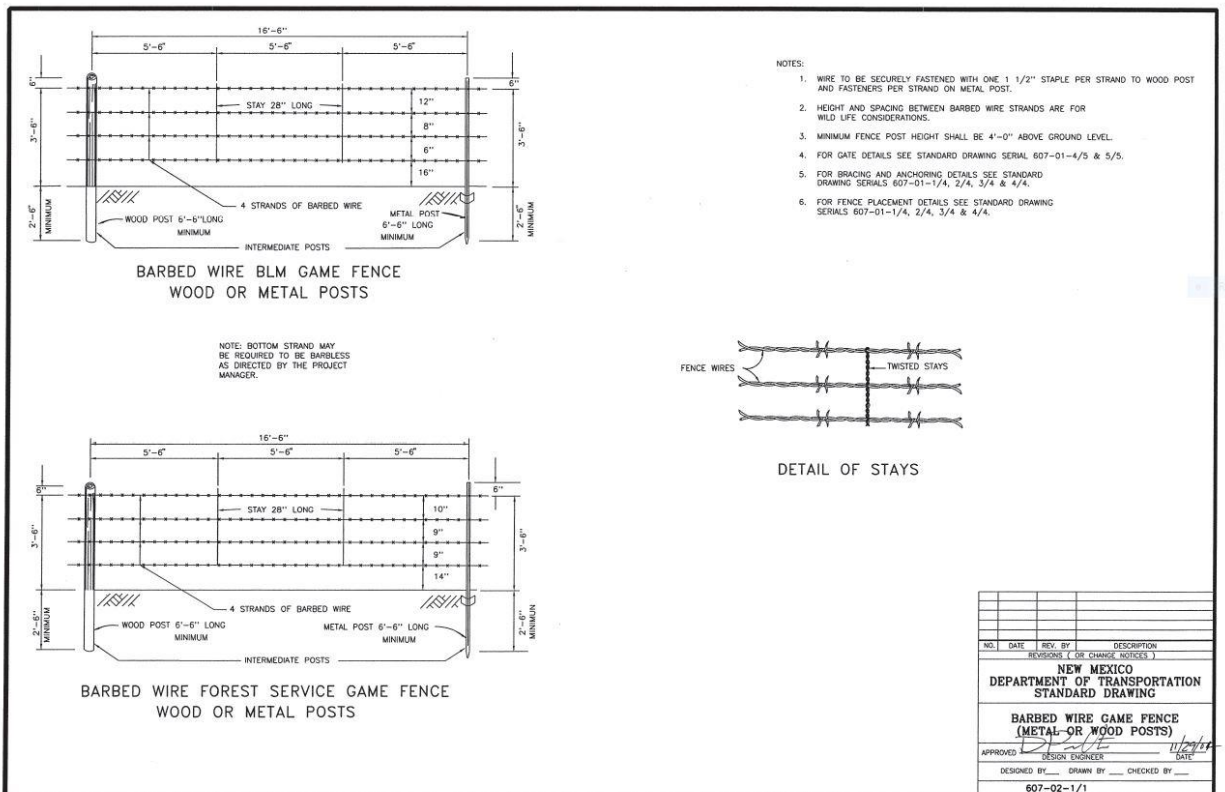
Sheet 607-05

**FIGURE 81 NMDOT wildlife friendly right-of-way fence plan sheet**

an obstruction. Although obstructions such as these may seem to be minor details when designing and planning mitigation projects, they play a major role in a project's success. If fencing or gates are required for livestock management, wildlife friendly ROW fencing should be used (Figure 81). Wildlife friendly fencing has a total height of 42-in., contains 4 wire strands, and has the bottom wire between 14-in. and 16-in. from the ground. The bottom wire can be smooth. The top two wire strands are spaced between 10-in. and 12-in. apart and can also be smooth wire. The fences or gates should be installed away from the crossing (i.e., on the ROW boundary) and can satisfy the objectives of mitigation and livestock management (Figure 82).

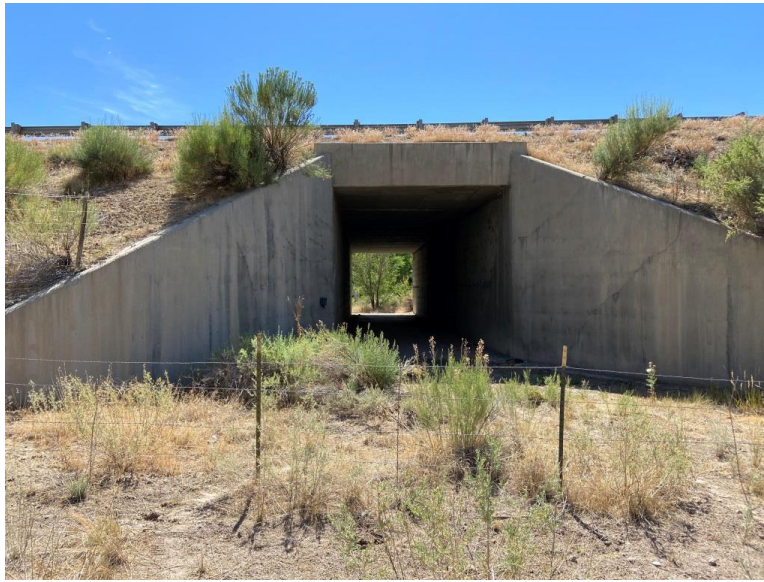
**FIGURE 82 A wildlife friendly fence placed on the right-of-way boundary near an upsized CBC north of Aztec on US 550 within San Juan County, New Mexico**

**Recommendation** – Limit livestock access to the wildlife crossing structure by installing a wildlife friendly ROW fence.
